## Application Notes

### AN11 - INC – Bootloader Firmware Upgrade Procedure

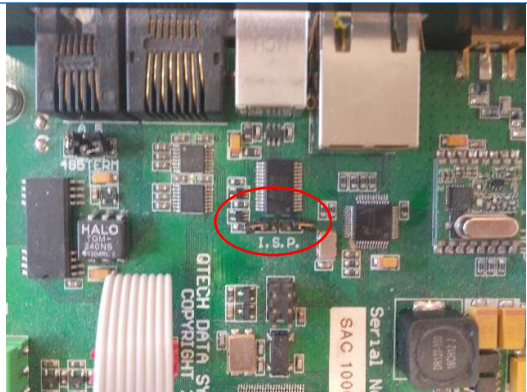
Step	Procedure	Notes
1	Turn off the power to the INC	
2	Carefully remove the case lid of the INC. There are no screws to remove.	
3	Locate the In-System-Programming (ISP) jumpers and insert the jumpers

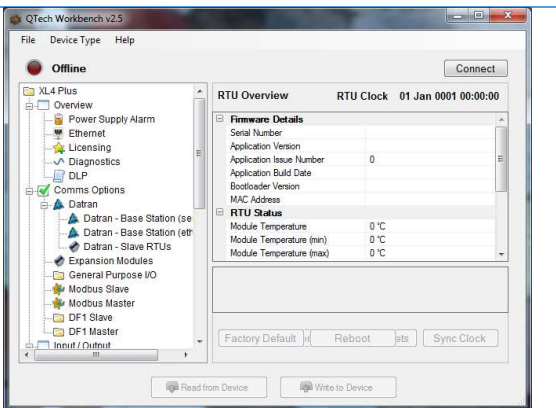
<p>5 Connect the USB cable to the laptop and launch Water-Insight Workbench software</p>

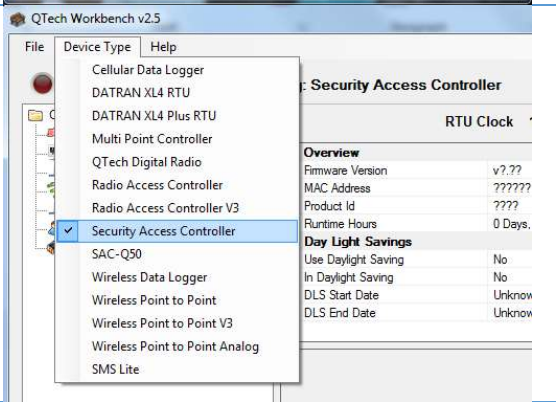
<p>6 Select the <u>SAC</u> device type in Workbench</p>

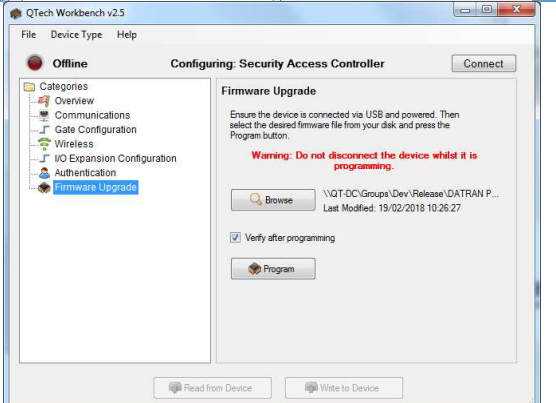
<p>7</p> <ul style="list-style-type: none"> <li>• Select the Firmware Upgrade Category</li> <li>• Browse to locate the firmware upgrade file supplied by Water-Insight.</li> <li>• Click the program button</li> </ul>
